CASUALTY REPORT

**DIVISION FOR INVESTIGATION
OF MARITIME ACCIDENTS**

Collision between Chinese bulk carrier FU SHAN HAI and Cypriot container vessel GDYNIA

FU SHAN HAI sank after the collision

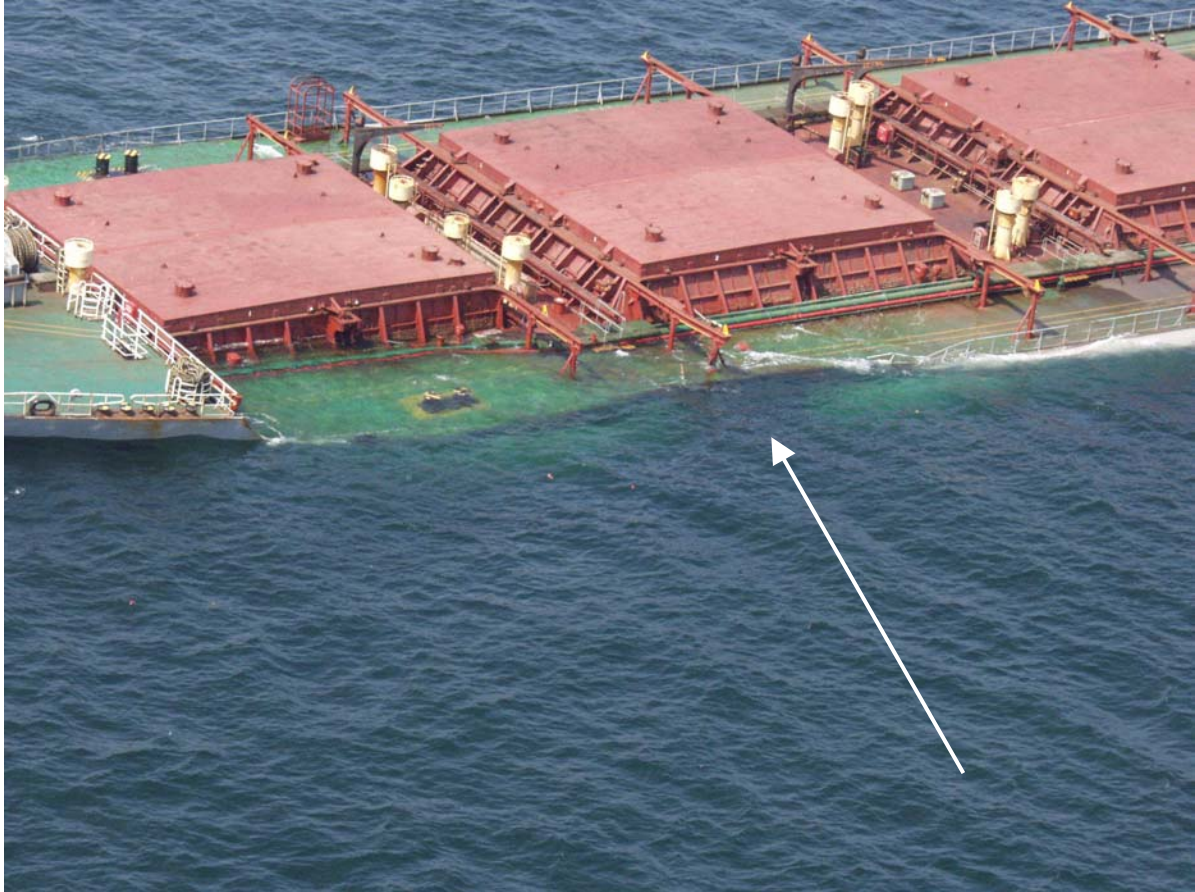
Photo taken by the Swedish Coast Guard

FU SHAN HAI was hit on port side between hatch No. 1 and No. 2.

On the above picture there is a dark area, which shows a comprehensive leakage on the ship's side at the indicated location.

Soundings on board confirms that there was damage to No. 1 and No. 2 port top side tanks, No. 1 and No. 2 port double bottom tanks and hold No. 1 and No. 2.

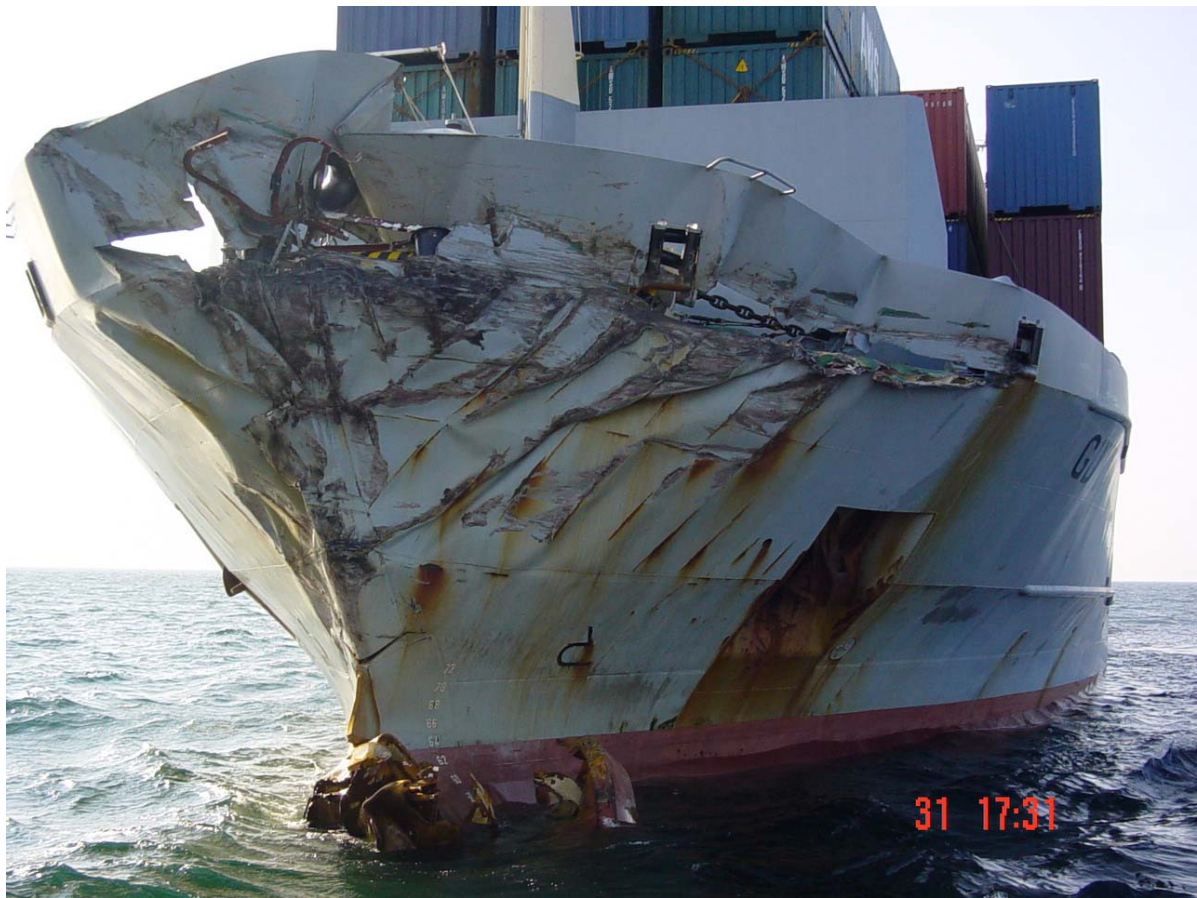
Photo taken by the Danish Police

The damage on GDYNIA was relatively limited. The stem of the vessel is strongly built and the hull has been designed such as to comply with the requirements for navigation in ice. The class notation "E1" correspond to ice class "IC" of the Finnish / Swedish Ice Class Rules of 1985.

GDYNIA's tanks were found intact except for the forepeak tank.

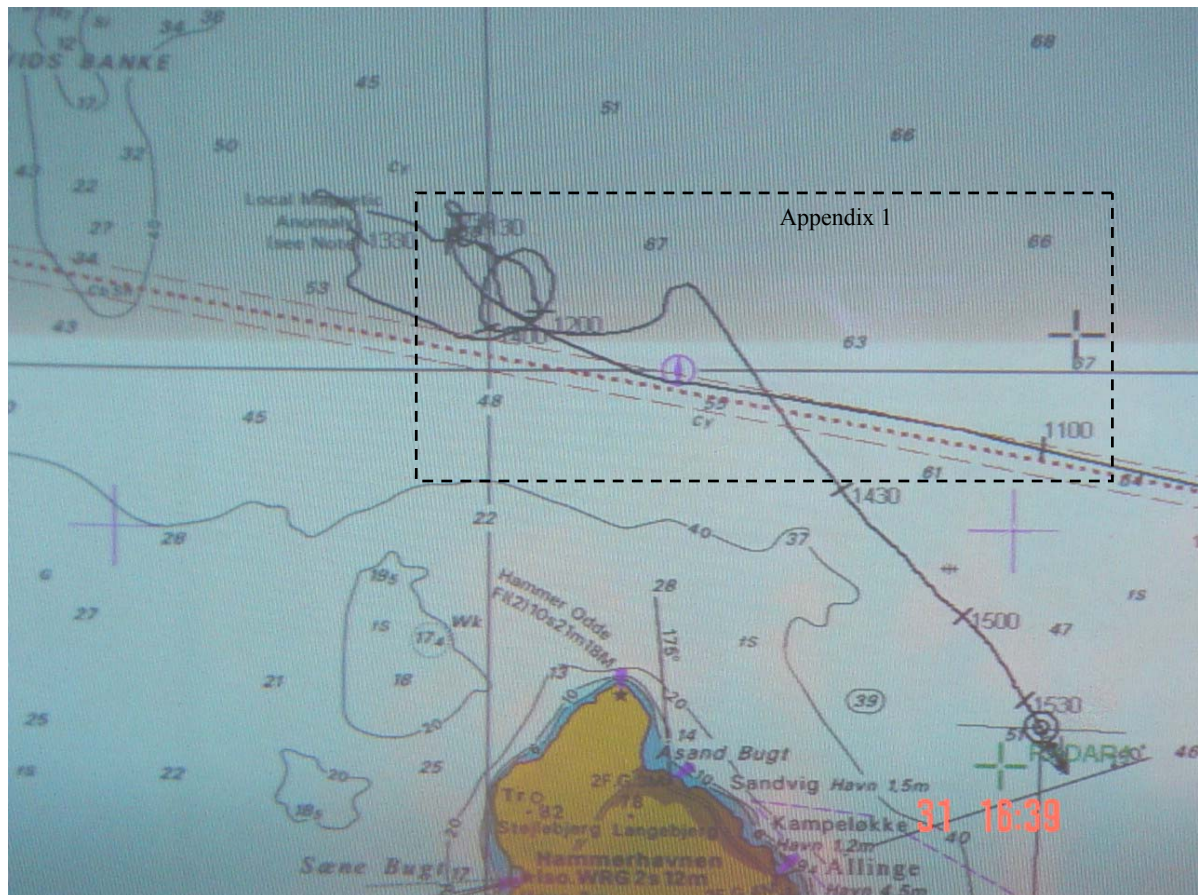
Track from electronic chart on board GDYNIA

The track of GDYNIA was plotted on the electronic chart of the vessel. When the Danish police was on board on 31 May 2003 at 1639 hours, photos were taken of the electronic chart, showing the track of GDYNIA from before 1200 hours local time (on photo 1100 (UTC +1)).

When the Danish Division for Investigation of Maritime Accidents came to Gdynia on 3 June 2003, the track had been erased by accident by the crew of GDYNIA.

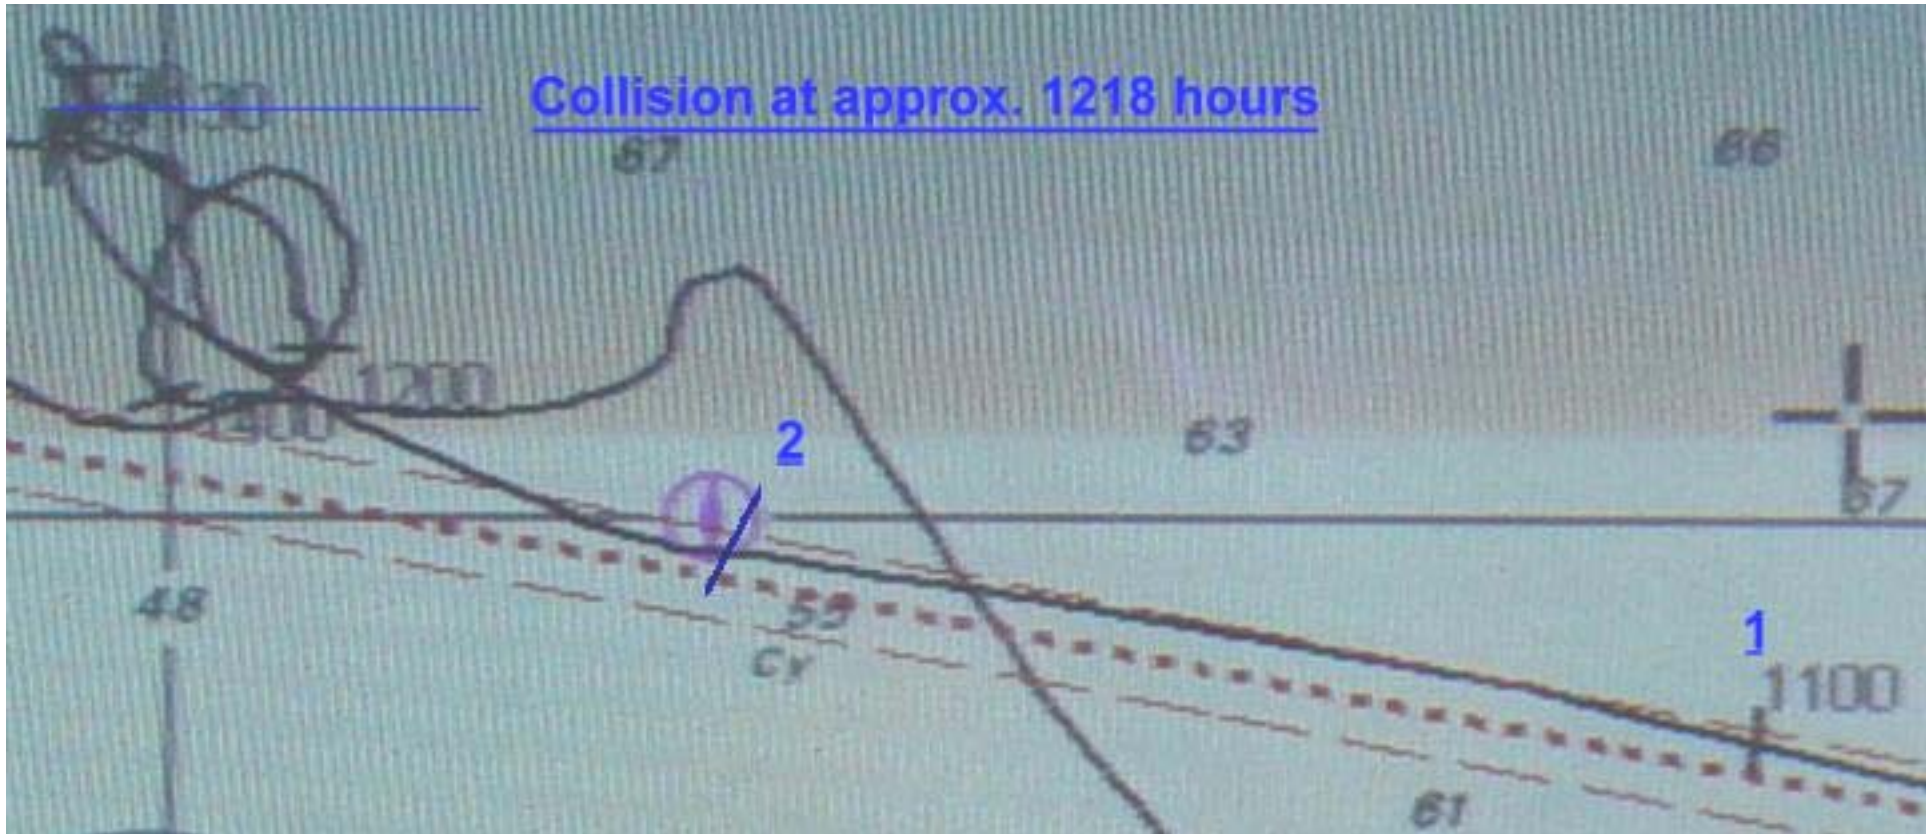
Appendix 1

Enlargement of track from electronic chart of GDYNIA.

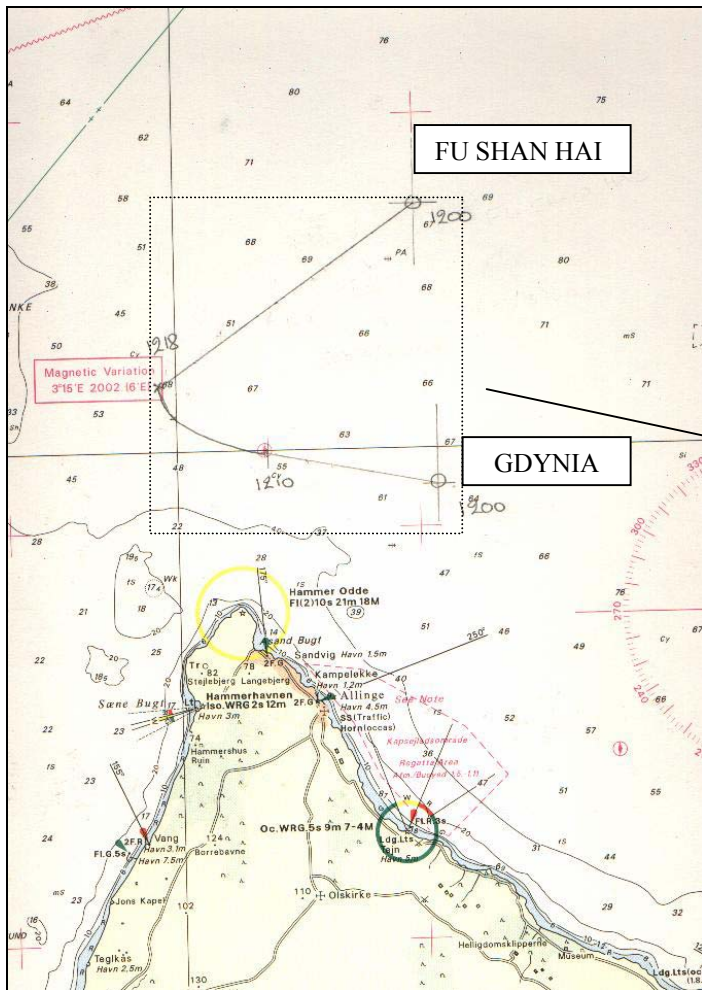
Appendix 2

Reconstruction of the course of collision based on the information from GDYNIA and FU SHAN HAI

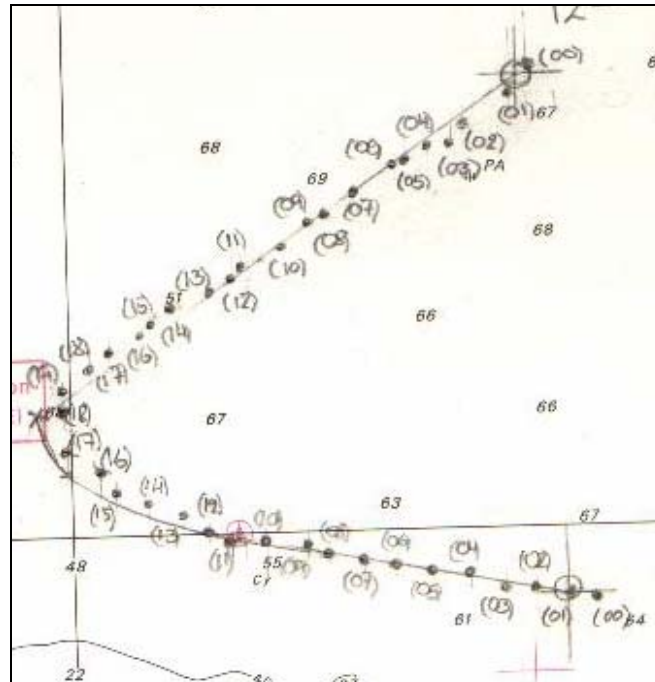
Reconstruction incl. approx. positions for every minute in the period from 1200 to 1219 hours based on radar tracks received from Radar Central Malmö.
